This report presents the results of visual and photographic underwater surveys from the shoreline to a depth of 600 feet along selected routes off the eastern coast of Andros Island, Bahamas. Additional oceanographic and meteorological data are included which were obtained during previous surveys. This is the U. S. Naval Oceanographic Office's first survey utilizing SCUBA equipped divers and submersibles and represents a further expansion of our data collection and survey capabilities to provide a more lucid presentation of ocean environmental characteristics.

The survey was performed to provide information applicable to the installation of submarine cables in support of the U. S. Navy's Atlantic Undersea Test and Evaluation Center.

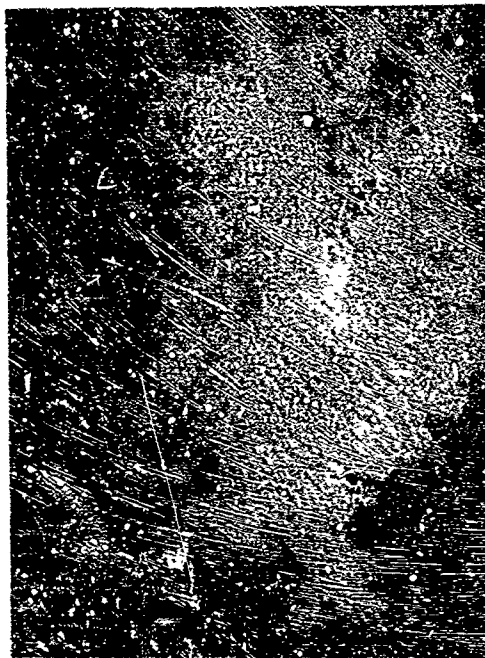
PLATE 10. BIG WOOD CAY (A) & (B) OUTER PLATFORM, DEPTH 18 FEET. HEAD IN (A) IS 8 FEET LONG AND 4 TO 5 FEET HIGH. DOMINANT CORAL IN (B) IS *MONTASTREA ANNULARIS*. (C) & (D) DEPTH 24 FEET SHOWING HEADS AND RIPPLE MARKED SAND ASSOCIATION.

The barrier reef is less distinct along the survey track off Big Wood Cay than at Salvador Point, and is delineated by an increase in coral abundance and species. A few hundred yards north and south of the survey track, the reef is well-developed and stands a few inches above the water surface at low tide. Seaward of the reef the outer platform is similar to that described at Salvador Point. The bottom changes from a forest of coral heads off-reef to a spur and groove configuration in intermediate areas, and finally to a texturally rough and abrupt break-in-slope (Plates 10 and 11).

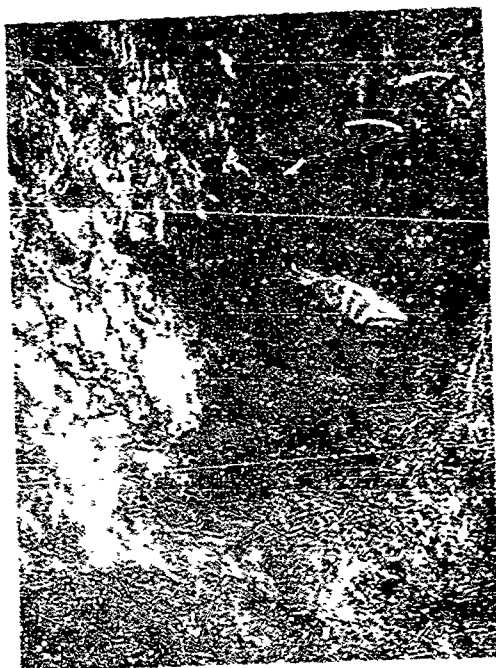
PLATE 23. HIGH POINT CAY, SERIES OF PHOTOGRAPHS SHOWING EDGE OF OUTER PLATFORM AT 130 FEET DEPTH.
NOTE UNDERCUT WALL AT PLATFORM'S EDGE IN (A).
